**Flood Control Project Maintenance
Levee Inspections**
LMA District Cover Sheet
Spring 2018 Levee Inspection Results

Reclamation District No. 1660 Tisdale

Levee Inspection Report By Mile - Spring 2018

Waterway	Bank	Unit Miles	Inspection Start/End	Inspector
Unit No. 01 Sacramento River	Left	2.94	03/15/2018 03/15/2018	Bob Duffey

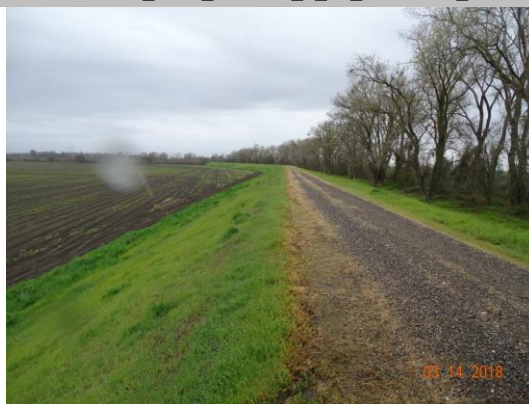
Photo 1 of 1 : SP_2018_RD1660_8_19_20180402_00017.jpg

LM Start	0.59	Rating **	A	Issue No.	19
LM End	0.59	Issue Type +	Ma	Location *	LS
Category	Earthen Levee			GPS Latitude/Longitude	
				Start	End
Item	Vegetation			39.054918 °	39.054918 °
				-121.839208 °	-121.839208 °
DWR ID	DWR_RD1660_01_s_2018_19				
Comment Code					
V1 : Control annual grass and weeds on the levee slopes and easements.					
Inspector Comment					
Native grasses on both slopes are adequately maintained.

View of the native grasses on both slopes.

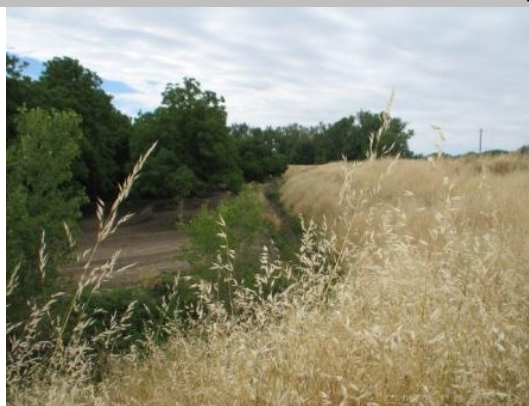
Photo 1 of 1 : SP_2018_RD1660_8_1_20180305_00001.jpg

LM Start	2.01	Rating **	U	Issue No.	1
LM End	2.34	Issue Type +	En	Location *	LS
Category	Earthen Levee			GPS Latitude/Longitude	
				Start	End
Item	Encroachments			39.037640 °	39.034416 °
				-121.828421 °	-121.825698 °
DWR ID	DWR_RD1660_01_s_2012_1				
Comment Code					
DT : Ditch					
Inspector Comment

View of a large ditch along the landside toe.

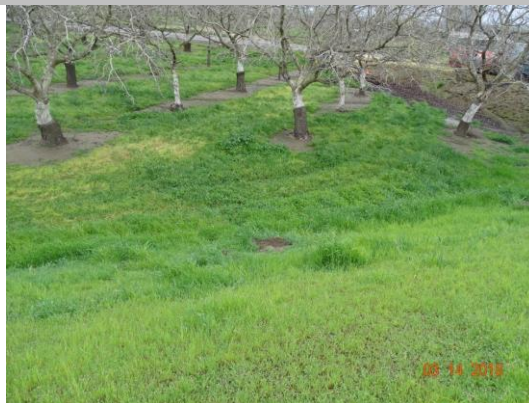
Photo 1 of 1 : SP_2018_RD1660_8_20_20180402_00018.jpg

View of the rodent holes along the landside slope.

LM Start	2.57	Rating **	M	Issue No.	20
LM End	2.57	Issue Type +	Ma	Location *	LS
Category	Earthen Levee			GPS Latitude/Longitude	
				Start	End
Item	Animal Control			39.031625 °	39.031625 °
				-121.823492 °	-121.823492 °
DWR ID	DWR_RD1660_01_s_2018_20				
Comment Code					
A3 : No rodents visible, but rodent burrows visible; need to backfill and compact or grout burrows.					
Inspector Comment					
Repair the rodent holes along the landside slope.

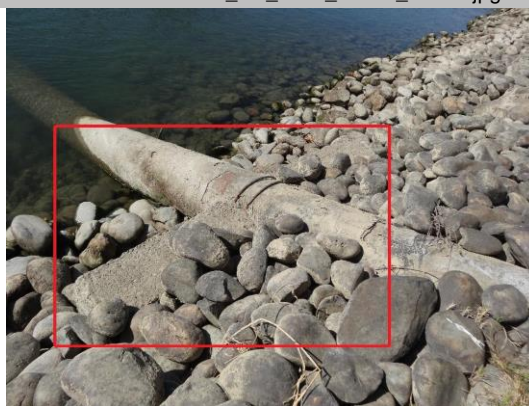
Photo 3 of 3 : UCIP_SP_2018_22632_38176.jpg

Comment Code						
Inspector Comment						
FS_ID:22632						
DS_ID:22492						
EP_NO: 10012						
Repair Type: Non-Urgent						
Crossing Status: Found						
UCIP Comments: - abandoned pumphouse on landside toe. Needs confirmation from LMA or DWR Inspector about abandonment of pumphouse.- headwall on channel bank.						
FIELD_STRUCT_DESC: 24-inch steel irrigation discharge pipe through the levee, 24 feet below the crown. Slide gate on the waterside (WS) shoulder. Abandoned pump house on the landside (LS) slope.						
(Retention of a 24-inch steel pipe through the levee, 24 feet below the crown, slide gate, and pump house authorized under Automatic Board Order (ABO) issued as Permit No. 10012, 1974 - Lawrence C. Harris).						
[Additional Reference(s): DWR Levee Log, 2005].						
FS Date: 10/10/2013

WS view: closer view of inlet steel pipe immersed into channel water.
Pipe was supported by concrete headwall.

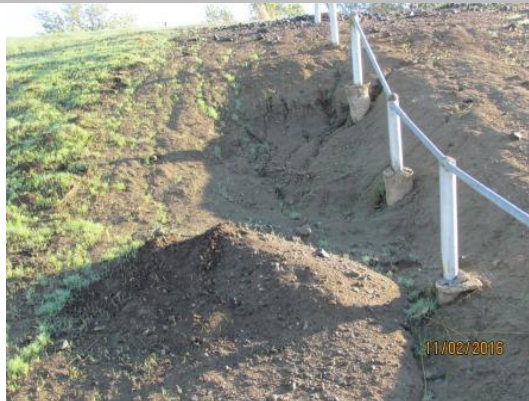
LM Start	0.00	Rating **	M	Issue No.	6
LM End	0.00	Issue Type +	Ma	Location *	LS
Category	Earthen Levee			GPS Latitude/Longitude	
				Start	End
Item	Slope Stability			39.032910 °	39.032910 °
				-121.743665 °	-121.743665 °
DWR ID	DWR_RD1660_02_f_2016_6				
Comment Code					
S1 : Repair slope instability.					
Inspector Comment

View of the slope instability looking from the landside toe.

Another view of the slope instability looking from the levee crown.

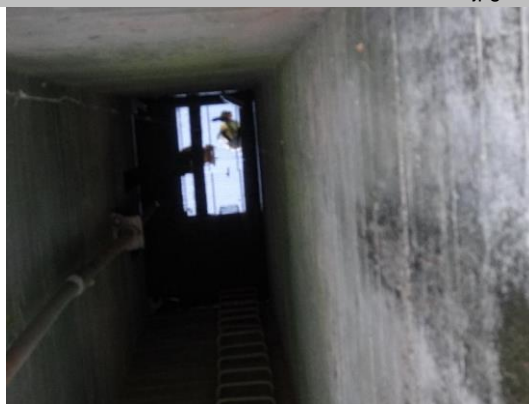
Comment Code					
Inspector Comment					
FS_ID:22663 DS_ID:22495 EP_NO: 10020 Repair Type: No Action Needed Crossing Status: Found UCIP Comments: - pipe/opening not visible as it was submerged into water on both sides.- it seems that 36-inch concrete pipe through the levee. It needs confirmation from LMA/DWR Inspector.- USED bench mark on landside concrete vault. FIELD_STRUCT_DESC: [Reclamation District No. 1660 (RD1660) Drainage Pump] 48-inch by 84-inch reinforced concrete outfall structure through the levee, 34 feet below the crown. Slide gate in a 4-foot by 8-foot concrete riser on the waterside (WS) slope. (Retention of a 4-foot by 7-foot concrete culvert outfall drain through the levee, 34 feet below the crown, and a slide gate in a concrete well authorized under Automatic Board Order (ABO) issued as Permit No. 10020, 1974 - Leo Bandoni, care of John Digardi). [Additional Reference(s): DWR Levee Log, 2005. USACE Sacramento O&M Manual 133, August 1955, (Station 1044+60), two 4-foot by 7-foot concrete tunnels referenced]. FS Date: 10/10/2013

WS view: 4 ft. by 8 ft. concrete box with slide gate on levee slope. USED bench mark on top of the box.

WS view: inside view of concrete box on levee slope. Slide gate in concrete box.

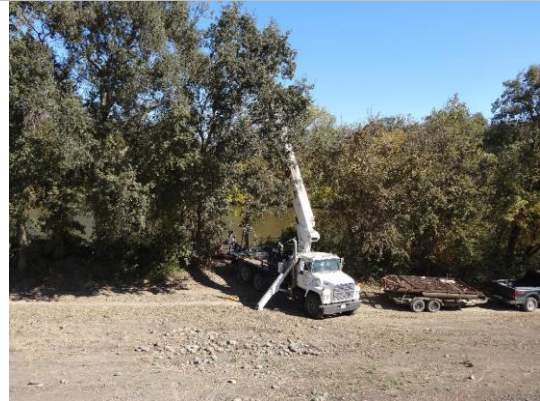
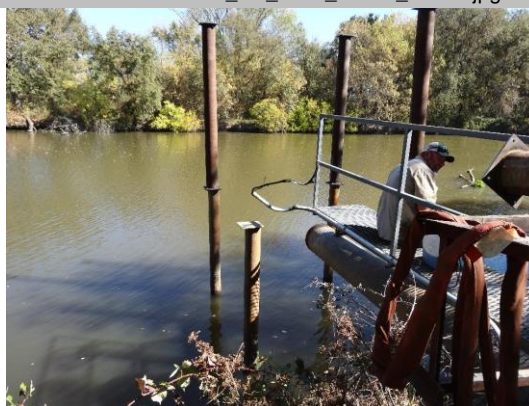
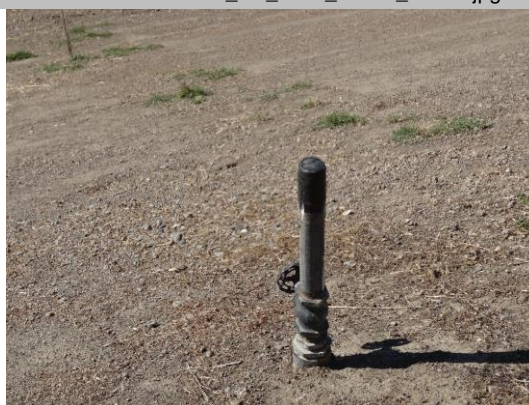
Comment Code					
Inspector Comment					
FS_ID:22705 DS_ID:22499 EP_NO: N/A Repair Type: Non-Urgent Crossing Status: Found UCIP Comments: Pressure relief valve on landside levee slope.Pump platform under construction for upgrade (raising platform)Look for new upgrade/revision permit. FIELD_STRUCT_DESC: 18-inch steel irrigation discharge pipe through the levee, 5.8 feet below the crown. Pump in the channel. Gate valve on the landside (LS) berm. Pipe discharges into a 4-foot by 4-foot concrete box on the LS berm. 2-inch electrical conduit of an unknown material through the levee, 3 feet below the crown. (Plans for construction of a pumping plant with an 18-inch discharge pipe through the levee authorized under Permit No. 4215, 1963 - S. A. McKeehan). [Additional Reference(s): DWR Levee Log, 2005]. FS Date: 10/15/2013

WS view: pump platform under construction.

WS view: pump platform under construction. 18" steel pipe and 2" electric conduit under steel platform.

LS view: pressure relief valve on levee slope.

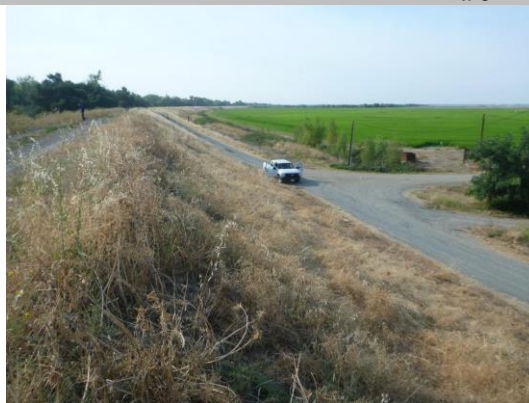
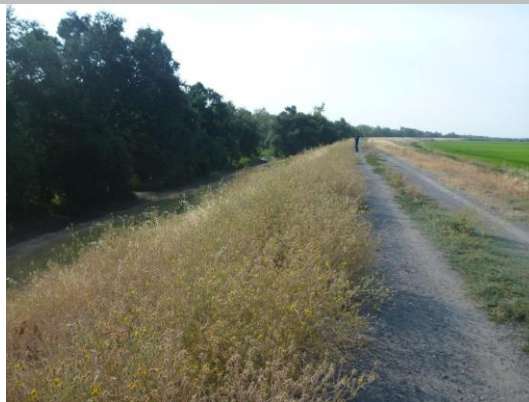
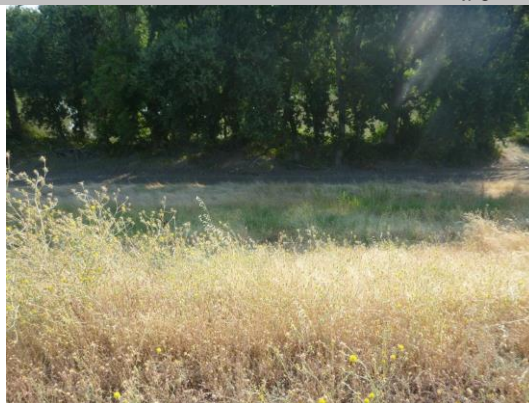
LM Start	5.12	Rating **	A/W	Issue No.	9	
LM End	5.12	Issue Type +	Ob	Location *		
Category	Supplemental			GPS Latitude/Longitude		
				Start	End	
Item	2017 Storm Damage			39.102537 °	39.102537 °	
				-121.775390 °	-121.775390 °	
DWR ID	DWR_RD1660_02_f_2017_9					
Comment Code						
Inspector Comment						
Levee Evaluation Comments						
Description:						
Site ID No:157						
Site Designation:RD 1660-01						
Repair Type: Seepage (B)						
Rating:Area of Concern						
Field Date:8/3/2017						
Notes: small bulges, levee prone to seepage

LM Start	5.12	Rating **	A/W	Issue No.	9 (cont)	
LM End	5.12	Issue Type +	Ob	Location *		
Category	Supplemental			GPS Latitude/Longitude		
				Start	End	
Item	2017 Storm Damage			39.102537 °	39.102537 °	
				-121.775390 °	-121.775390 °	
DWR ID	DWR_RD1660_02_f_2017_9					
Comment Code						
Inspector Comment						
Levee Evaluation Comments						
Description:						
Site ID No:157						
Site Designation:RD 1660-01						
Repair Type: Seepage (B)						
Rating:Area of Concern						
Field Date:8/3/2017						
Notes: small bulges, levee prone to seepage

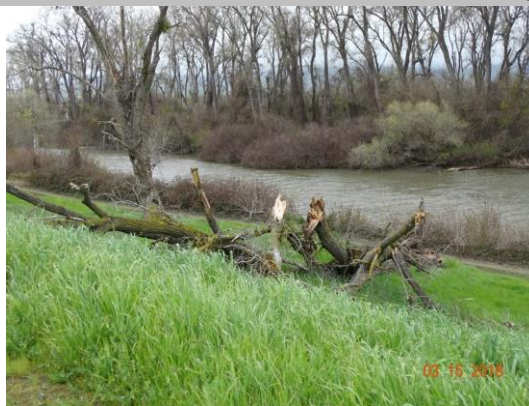
Photo 1 of 1 : SP_2018_RD1660_9_7_20180402_00024.jpg

View of the tree along the waterside toe.

LM Start	7.64	Rating **	C	Issue No.	26
LM End	7.64	Issue Type +	Ma	Location *	WS
Category	Earthen Levee			GPS Latitude/Longitude	
				Start	End
Item	Encroachments			39.124898 °	39.124898 °
				-121.812348 °	-121.812348 °
DWR ID	DWR_RD1660_02_f_2017_26				
Comment Code					
DE : Debris					
Inspector Comment					
Tree limbs was removed from the waterside toe.

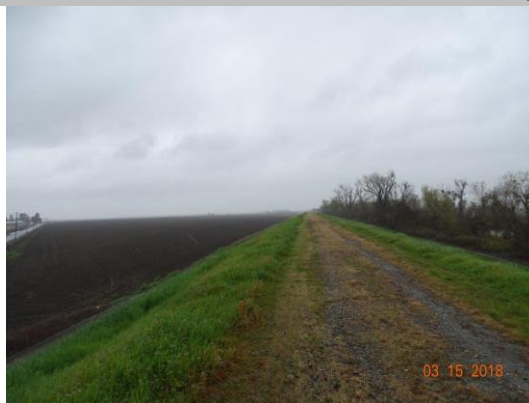
Photo 1 of 1 : SP_2018_RD1660_9_8_20180402_00026.jpg

View of the native grasses on both slopes.
